# BUILDING CONDITION ASSESSMENT

7672 Elgin Mills Road, Markham, Ontario  
February 25, 2021

Project Number: 20M-01500-00

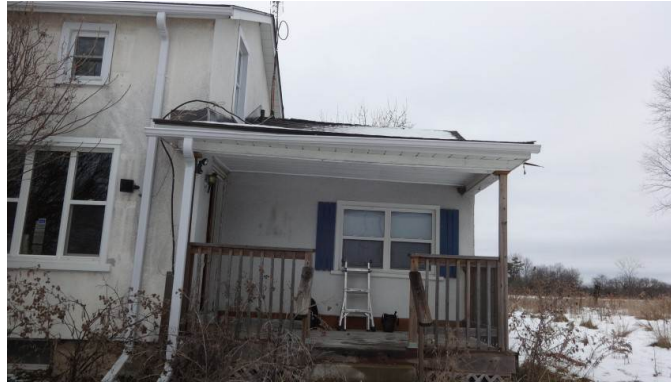
Photo No. 1: South Elevation

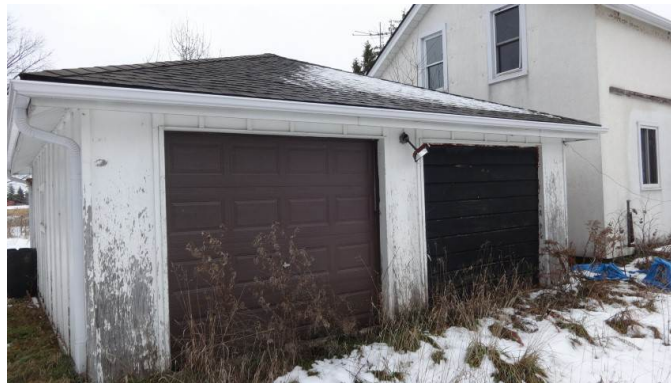
Photo No. 2: Northwest Elevation

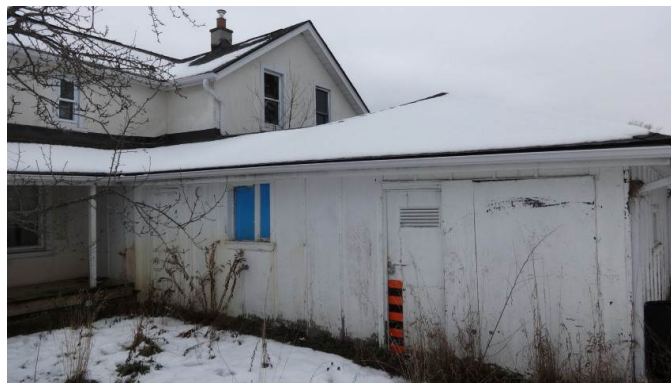
Photo No. 3: North Elevation and Garage

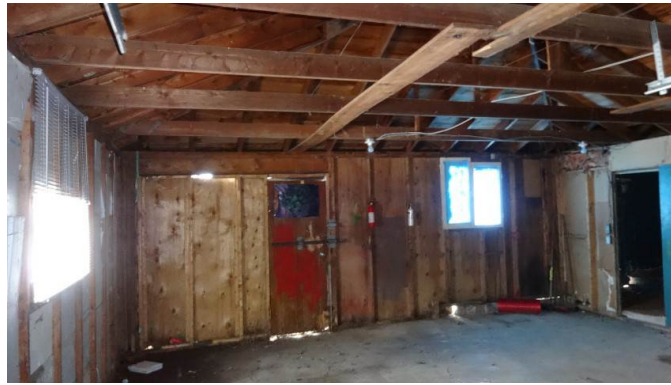
Photo No. 4: Attached Garage

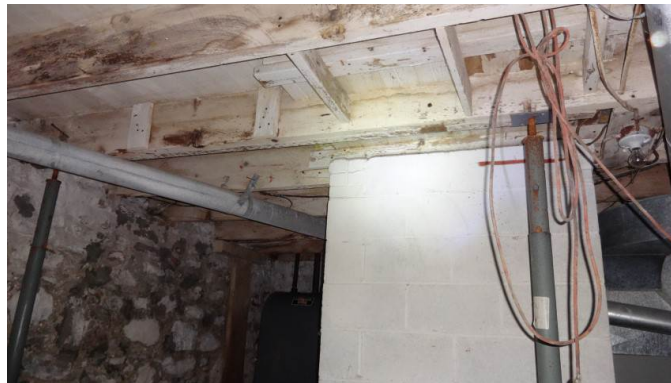
Photo No. 5: Main Floor Structure

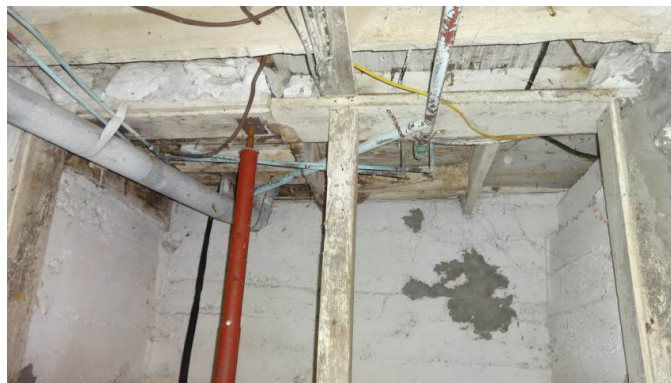
Photo No. 6: Additional Supports at East Side

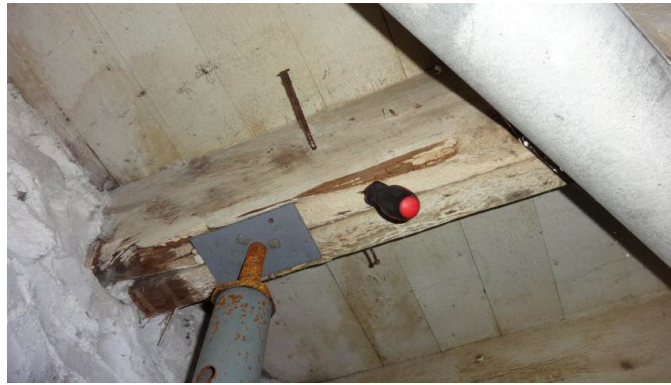
This project allows for retrofit structural repairs in the basement. Some retrofit work has been completed previously but is inadequate.

Photo No. 7: Weak Joist with Support

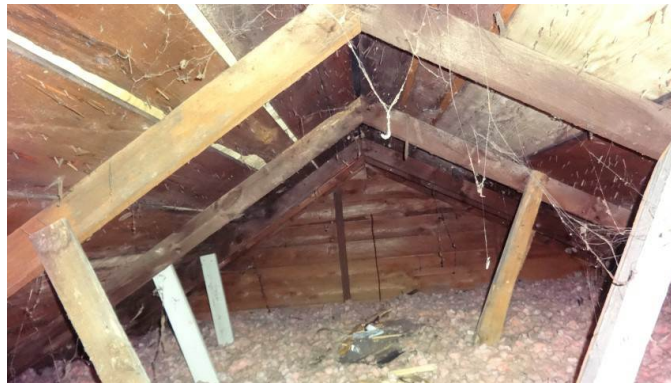
Photo No. 8: Addition Attic

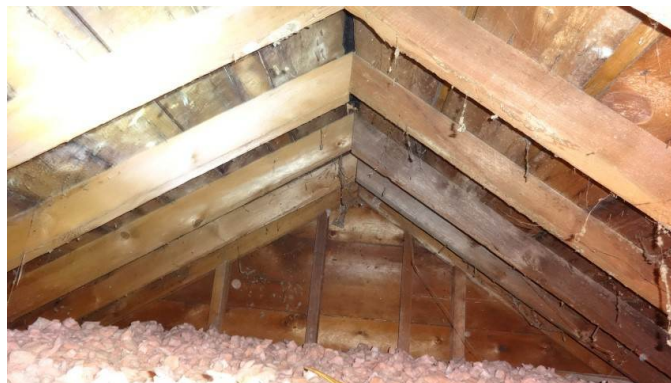
Photo No. 9: Original House Attic

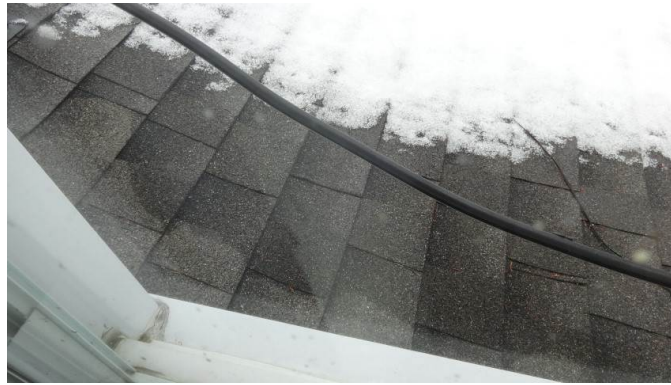
Photo No. 10: Shingles

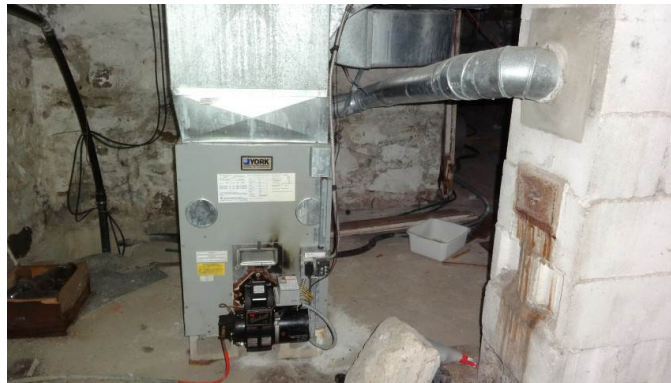
The furnace was not operational at the time of our review but it appears that the unit could be returned to operation. However, the oil tank is from 2005 and the furnace is from 2000 and both are approaching their typical expected service life so we expect replacement to be required. The tank heater is old (2002) and corroded so a replacement budget is included.

Photo No. 11: Furnace

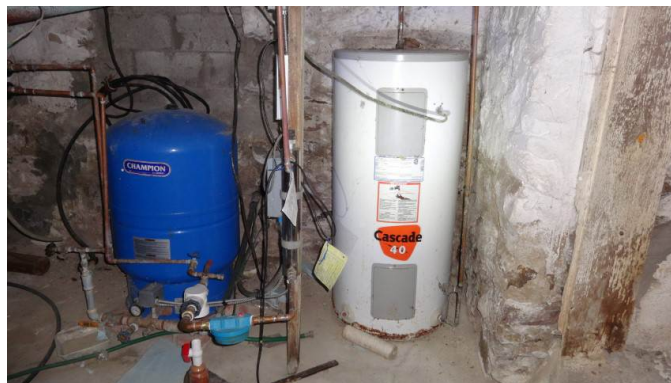
Photo No. 12: DHW Heater and Expansion Tank

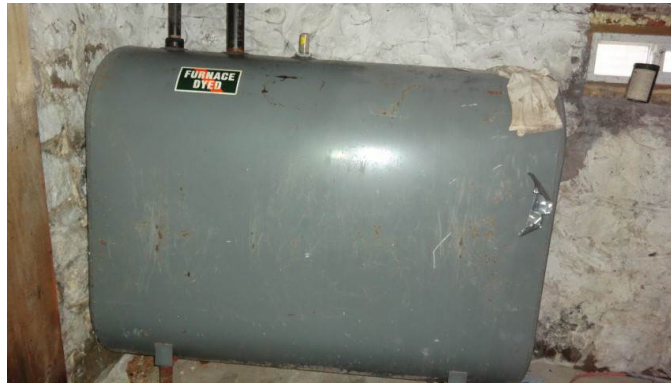
Photo No. 13: Oil Tank

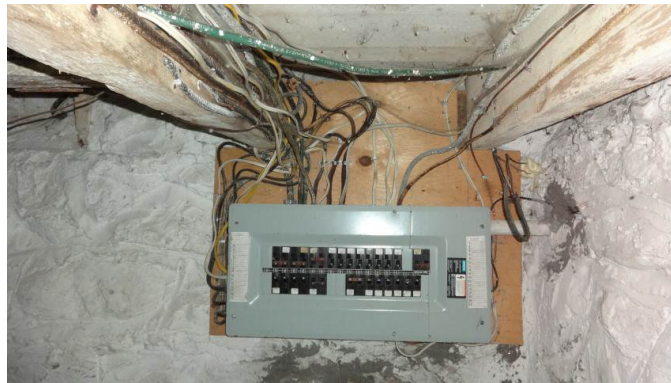
The electrical feed to the building is connected but the meter has been removed. The main panel is likely about 10-20 years old and can likely be maintained. However, the wiring is generally of older vintage and so general re-wiring is budgeted in conjunction with interior finish renewal.

Photo No. 14: Electrical Panel

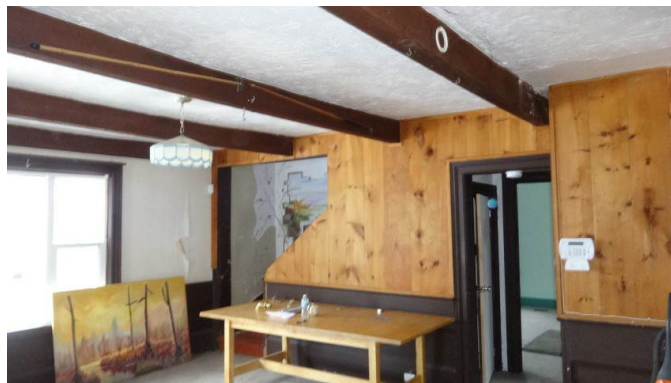
Photo No. 15: Main Floor

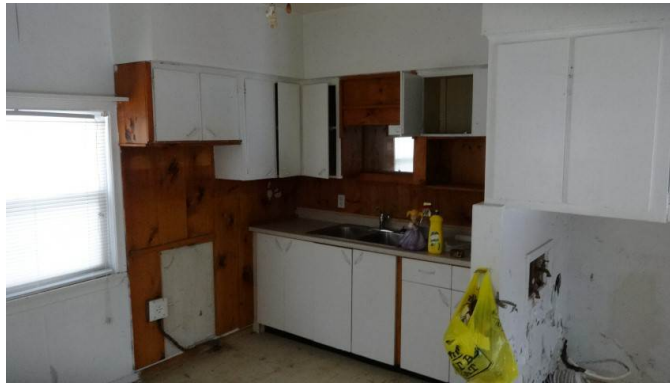
Photo No. 16: Kitchen

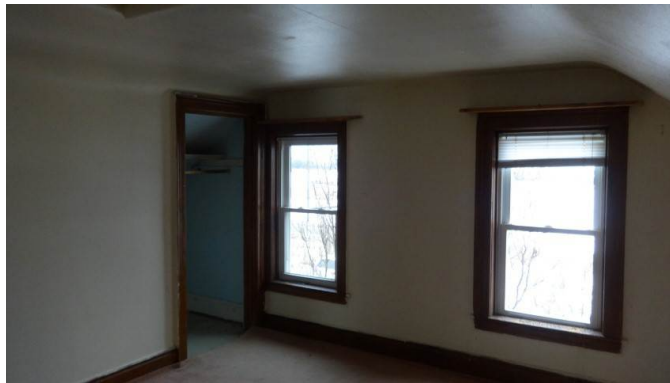
Photo No. 17: Upstairs Bedroom
